REMEDIATION T

Continual biological augmentation brings new life to eliminating the need for costly replacement

Douglas J. Nelson and Mark C. Noga

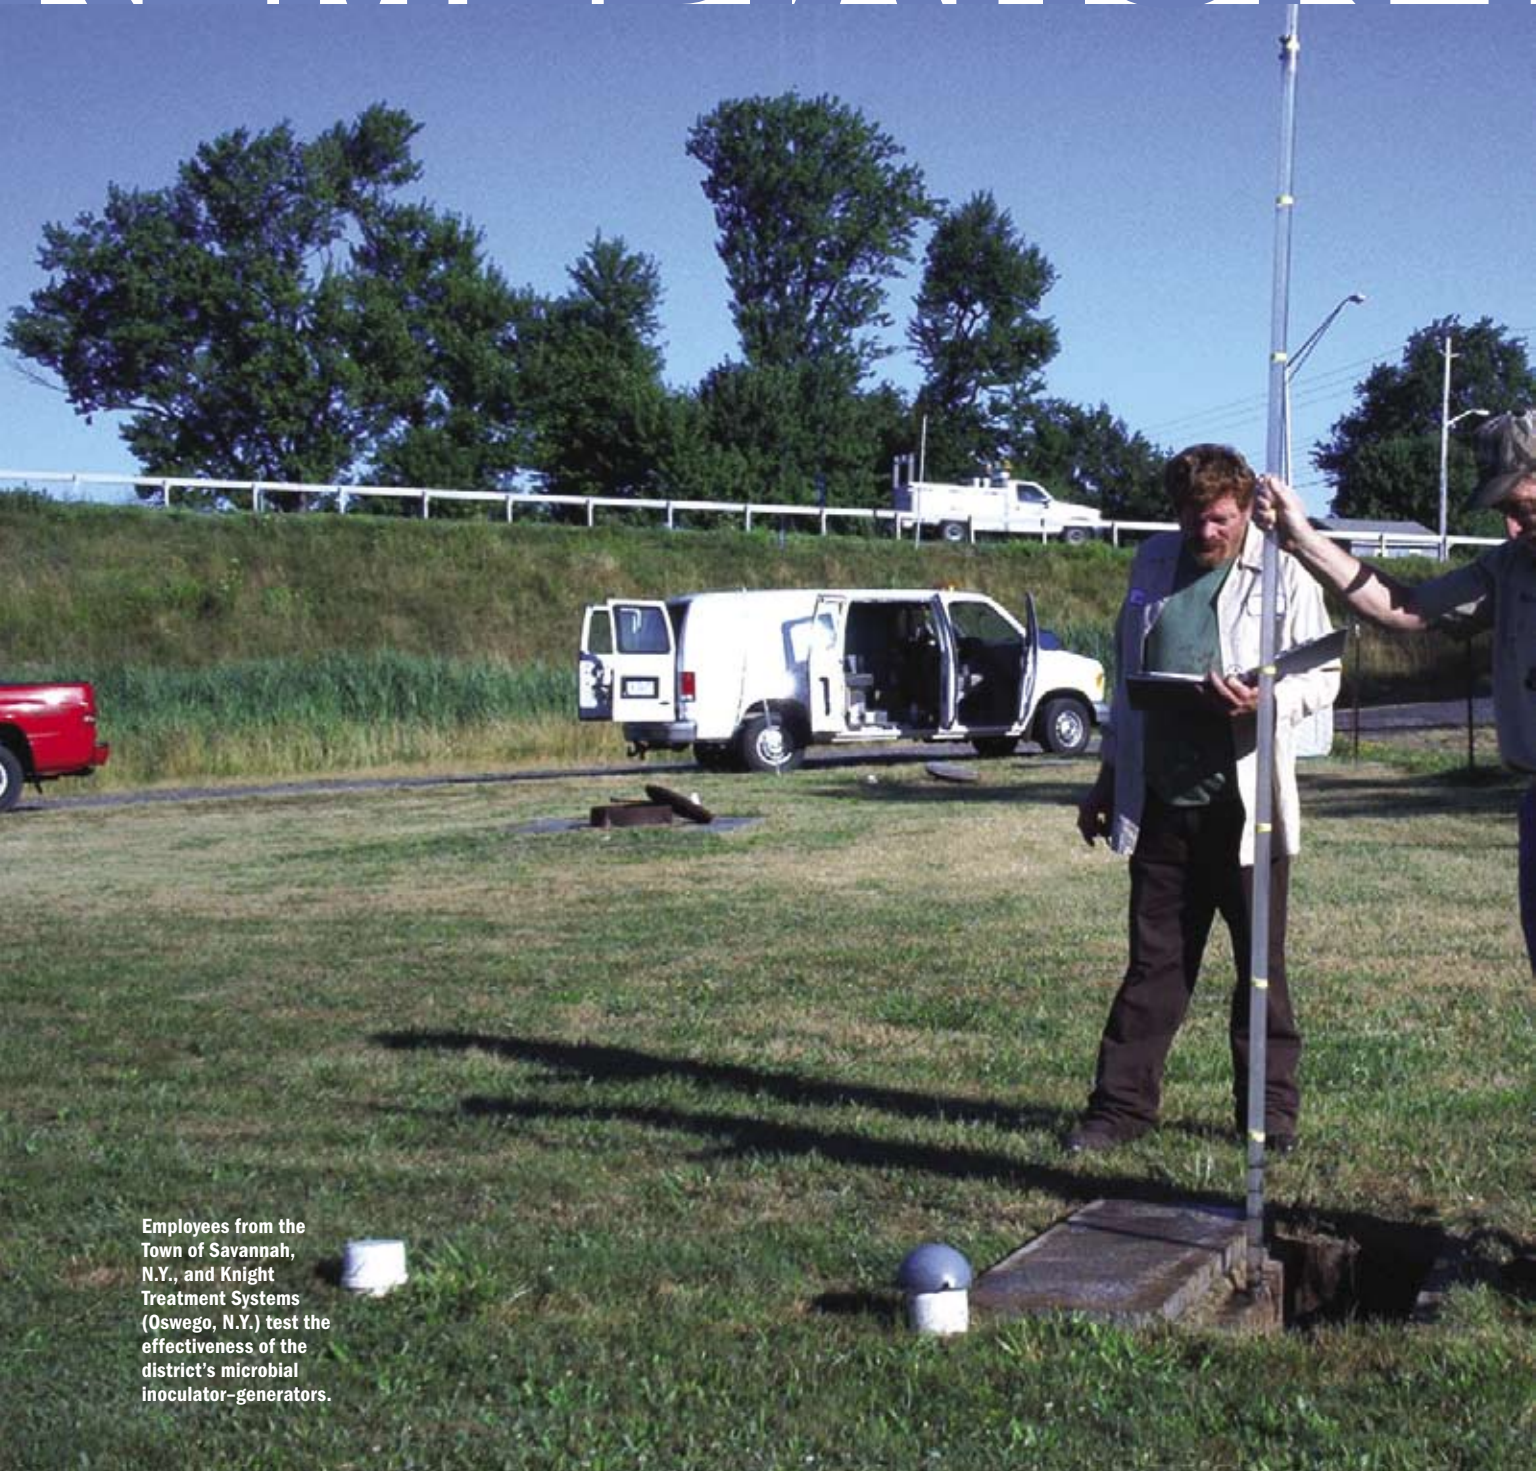
Employees from the Town of Savannah, N.Y., and Knight Treatment Systems (Oswego, N.Y.) test the effectiveness of the district's microbial inoculator-generators.

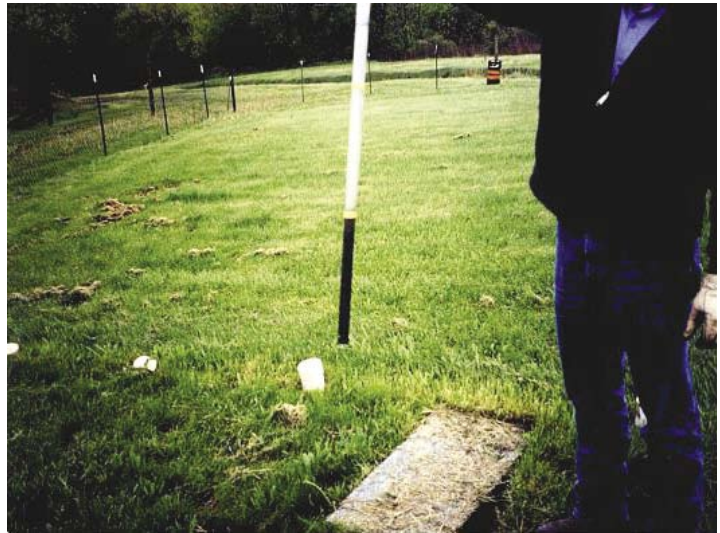
if it reduced ponding within the sand filter. During his 17-year tenure at the facility, the operator had never seen the bottom of the sand filter distribution boxes during an inspection. But approximately 6 weeks after installation of the microbial inoculator-generators, the level of ponding had subsided enough to allow him to do just that.

Before installation of the microbial inoculator-generators, water was ponded more than 76 cm (30 in.) above the filter sand.

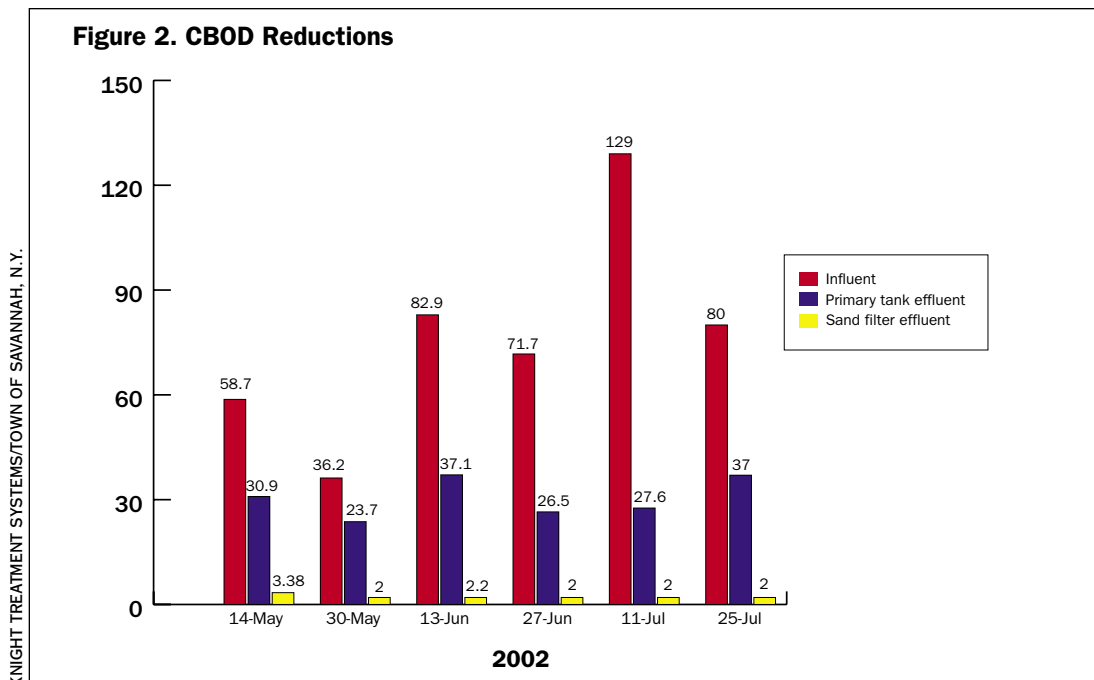
Test data were similarly encouraging. During the testing period, CBOD and TSS values for the effluent showed little change from preinstallation testing (see Figure 2, below, and Figure 3, p. 40). The level of treatment was not compromised by the reduction of the clogging mat originally found at the top of the sand in the filter. Physical observations of the filter surface indicated a significant biological growth that did not limit flow.

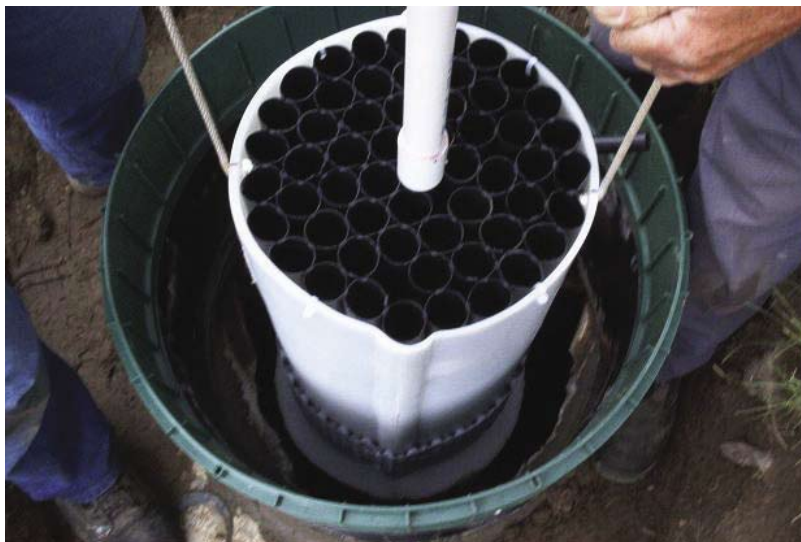
A microbial inoculator-generator is lowered into the treatment tank.

The microbial inoculator-generator is a tank insert that is designed to grow and inoculate downstream treatment units with specific strains of bacteria. A patented matrix of *pseudomonas* and *bacillus* bacterial strains that are well-proven to reduce biomat growth are inoculated into the treatment unit, where they reproduce for discharge to the downstream device. The treatment device consists of fixed-growth media within a columnar housing. The pilot design featured a suspended growth medium that was retained within the treatment unit by a grating. (The unit is similar in design to larger units used for municipal wastewater treatment, known as the integrated fixed-film activated sludge process. Such systems are not inoculated with specific strains of bacteria as was done in this study.)

Tank contents are circulated over the growth media by airlift action created by a fine bubble

diffuser in the base of the unit. Flow through each unit is estimated to be 95 m³/d (25,000 gal/d), thereby passing the contents of the 19,000-L (5000-gal) tank through each unit more than five times each day. Installation took place in May 2002 without the direct knowledge of the district residents to avoid atypical user patterns, which might skew the results.

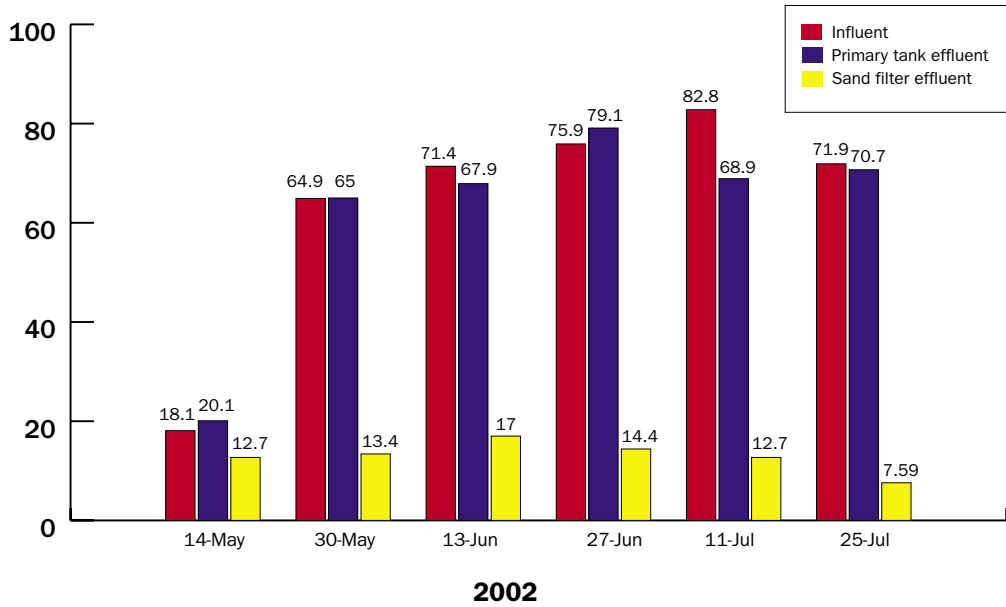
Figure 4. TKN Concentration

The most notable outcome of the pilot study was the apparent effect on the nitrogen cycle. Laboratory results indicated some nitrification about 4 weeks into the study and greater nitrification as the study progressed. The onset of nitrification was caused by a combination of several factors, including rising influent temperature, decreasing CBOD within the system, and increased oxygen concentration. Nitrification has maintained the effluent TKN below 20 mg/L — more than a 60%

reduction — consistently (see Figure 4, p. 41). It is assumed that nitrification was initiated by eliminating the ponding on the filter, thus lowering CBOD and increasing oxygen levels. Lack of alkalinity has not been eliminated as a limiting factor for further nitrification. Denitrification is probably taking place to a small degree, but with the low levels of CBOD within the sand filter, there is not enough carbon to support denitrification.

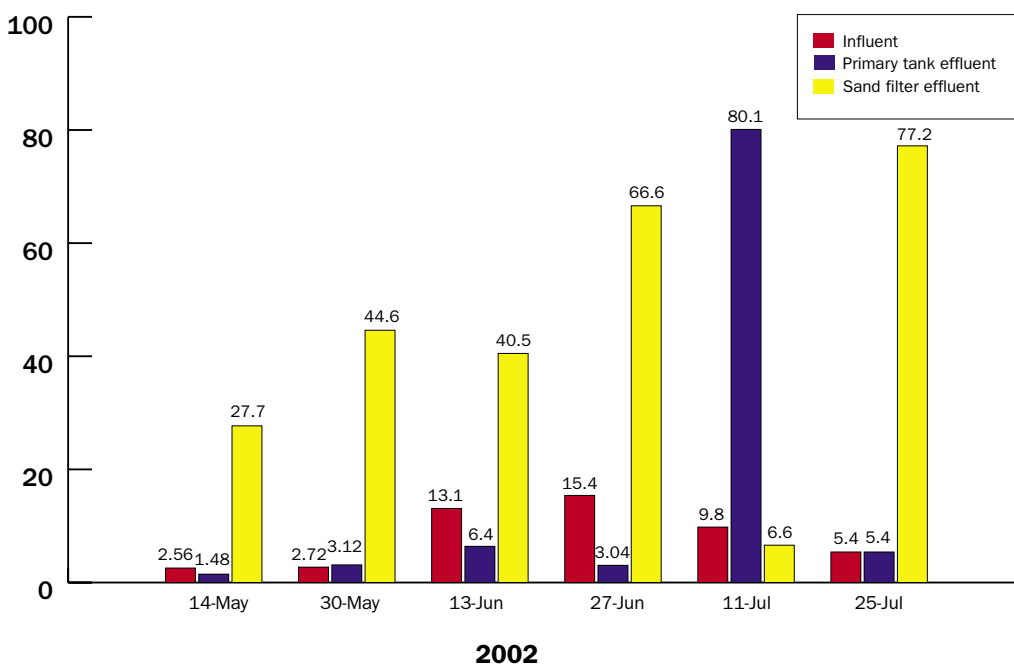
Figure 5. Nitrates

Test results for nitrates indicate two probable theories (see Figure 5, p. 41). Either denitrification was a significant factor during the July 11 sampling event or two sample containers, or their results, were inadvertently interchanged for that date. Unfortunately, there is no way to determine which of the two scenarios is correct. If the samples or their results were not switched during sampling, testing, or reporting, then the results indicate there was nearly complete nitrification within the treatment tank and equally effective denitrification within the sand filter on that date. This seems rather unlikely, and TKN

test results do not support this scenario. It is most likely that the samples were inadvertently placed into the incorrect bottles, but there is no direct evidence to support this theory.
