Sand Savior

A microbial inoculator generator successfully remediates a severe failure in an apartment building's sand filter treatment system

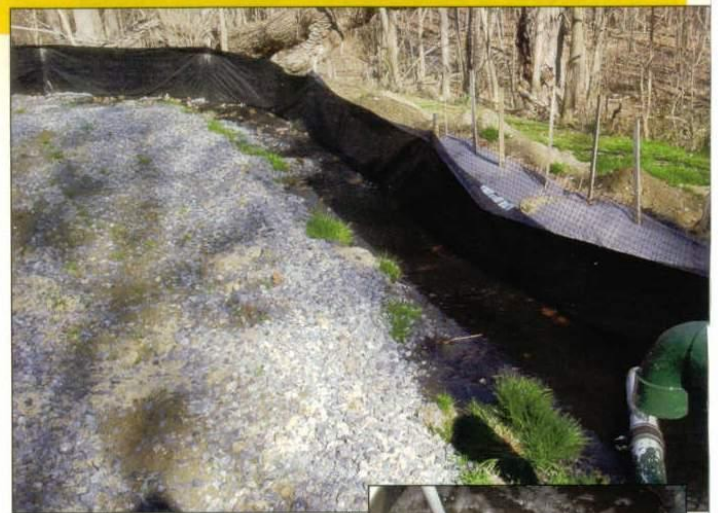
Above, sand filter effluent surfacing with diversion drain. At right, the White Knight treatment system in operation.

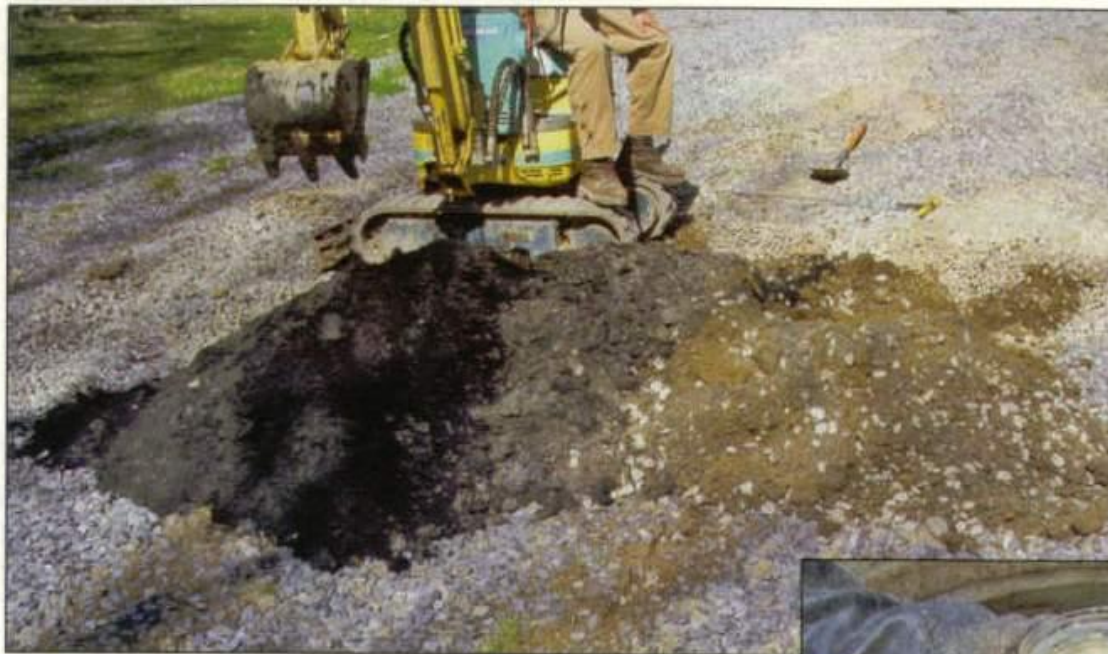
the street behind an intermediary property. The men dug two inspection ports and found significant ponding caused by an extensive organic clog mat. "The pump station had fallen into such disrepair that hydraulic pressure was gravity-feeding the bed," Rice says.

Top photo, an investigative dig into the old sand filter. Above, a typical water sample from a White Knight treatment tank sample. At left, the sand filter following remediation.

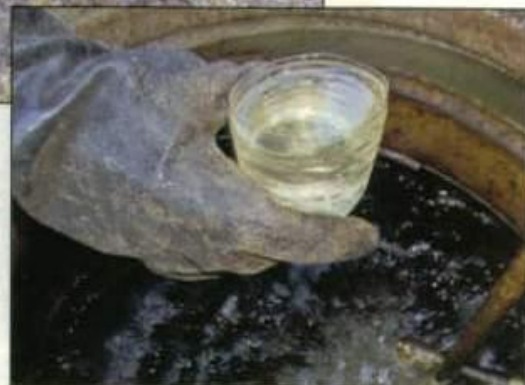
had reached equilibrium because it looked like pale lemonade and had visible colonies of thriving microorganisms," Rice says. "The tanks didn't have any solids in them and smelled faintly like flowers, which we attributed to laundry products."
